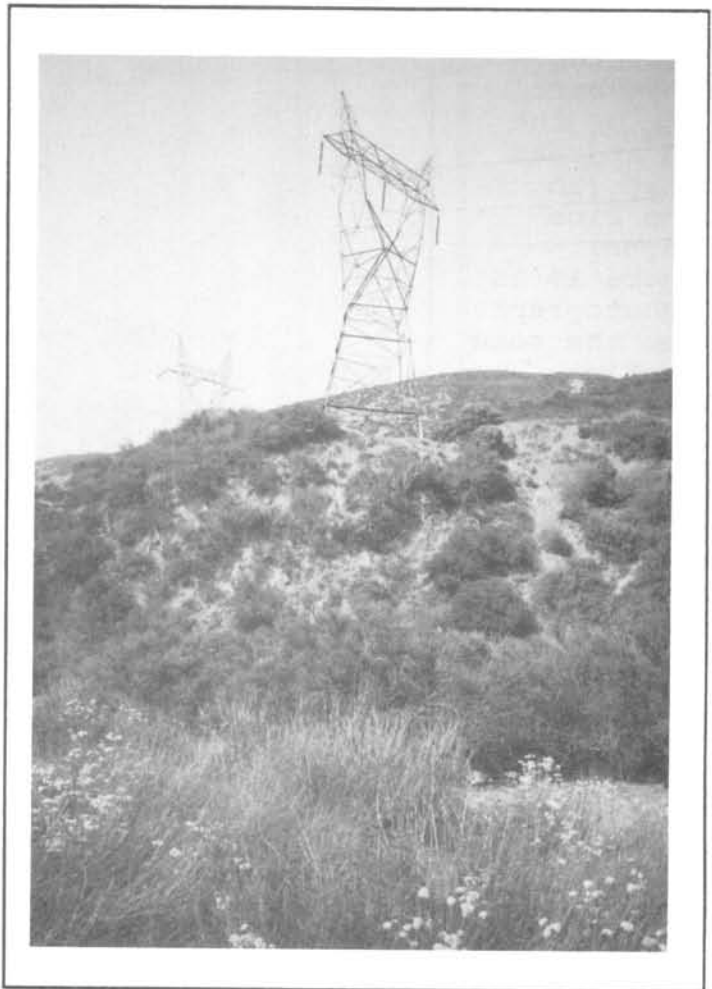
Figure 19 Power Tower At A Ravine Edge  
In The San Andreas Fault Rift Zone

The LADWP power lines cross the San Andreas fault zone in Lone Pine Canyon very close to where the petroleum products and a 36-inch natural gas transmission line cross the fault trace (see Figures 18 and 19). The expected 12 meter fault displacement causes a damage state 7 to all the lifeline components in this region, with a probability of 100%. The collocation scenario assumes that the resulting petroleum products spill (several miles of those pipelines could drain from the rupture, depending on how many other ruptures are assumed since the petroleum products pipelines run parallel to the fault trace for several miles) causes a 30-day delay in the repair activities while the resulting environmental and fire hazards are evaluated and mitigated. The general congestion in the area and the need to coordinate the use of heavy equipment so that its use will not adversely impact the other lifelines is assumed to add another seven days to the power line repair times. Because of the high probability of damage at this

location, the probable restoration time increases by 37 days. This accounts for about 75% of the collocation-induced delays in the restoration of service to the LADWP power lines.

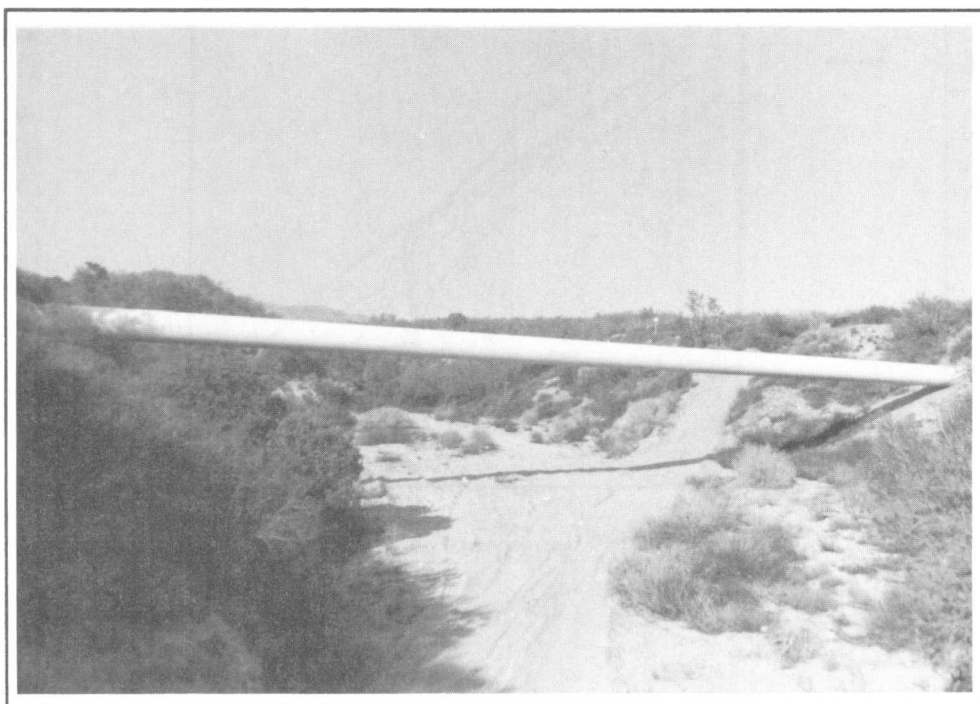
Figure 21 Typical Long Open Span On The 36-Inch Natural Gas Pipeline

Because they are buried, there are no convenient features that can be shown with photographs. However, there are 18 locations along the route of the western most 36-inch natural gas pipeline that are exposed spans which range from 10 to 138 feet in length. Figure 21 shows one of the longer spans across a dry creek bed north of Highway 138 and east of I-15. Figure 22 shows a location about 40 feet from the recently realigned Highway 138. At that location two 36-inch natural gas pipelines are routed parallel to each other. The line on the left is exposed, the one on the right is buried and marked with the surface sign. In general, open spans are estimated to increase the potential shaking damage state by up to 1 level, compared to a buried pipeline damage state condition.

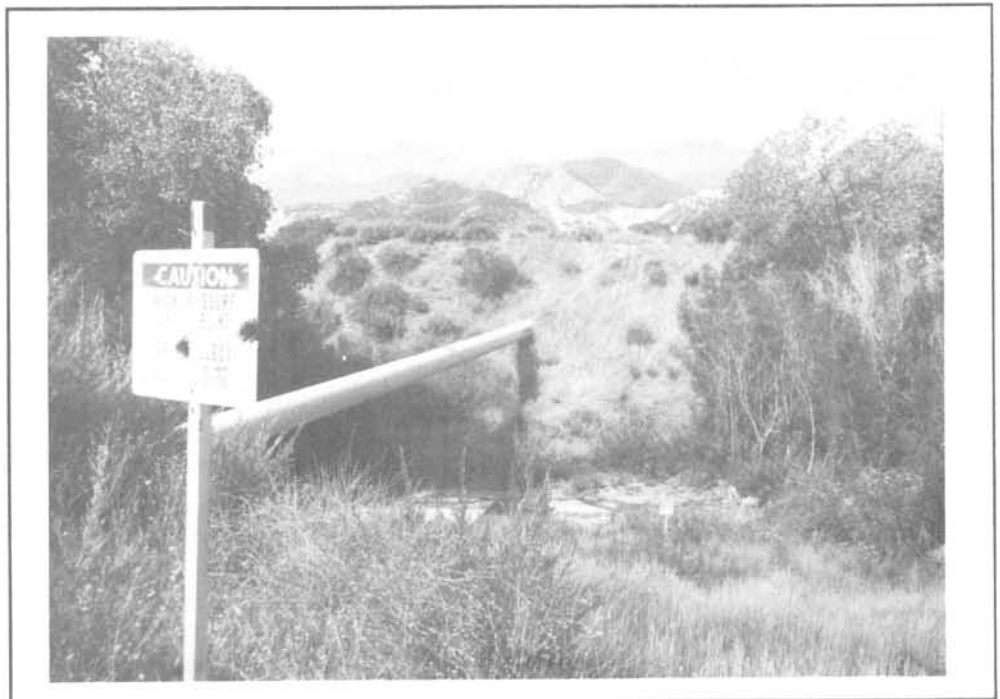
Figure 22 Two Natural Gas Pipelines Near Highway 138, One Buried, One Exposed

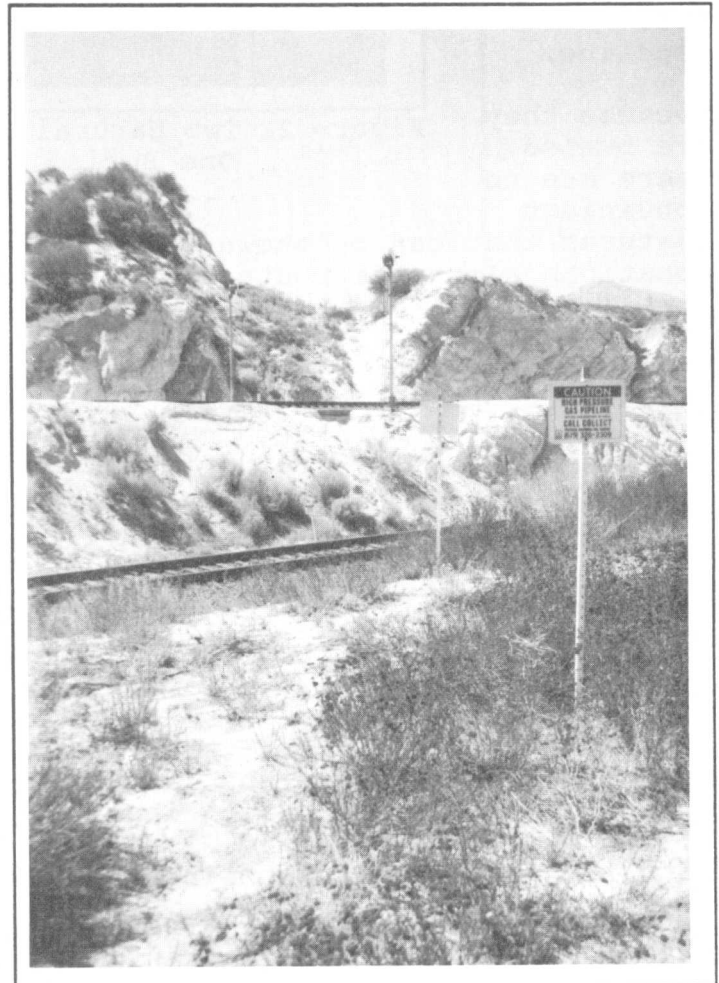
Figure 23 Natural Gas Pipeline Crossing Under Railroad Beds

Most of the pipeline highway or railroad bed crossings are cased crossings. However, none of the Southern Pacific crossings are cased, and a few of the I-15 and Highway 138 crossings are uncased. That occurred because the Southern Pacific did not require casing when they authorized the right-of-way crossing, and when I-15 replaced Highway 66 and when Highway 138 was recently realigned (in 1990-1991) they did not follow all of the old routes. At new crossings the pipeline was already installed, and new casings were not required to be retrofit.
